SWEETWATER LAKE DAM (7-10)

2023 Dam Safety Inspection Report
Brown County, IN | February 2024
Inspection Date: October 24, 2023

Burke Project No. 19.R230291.00000

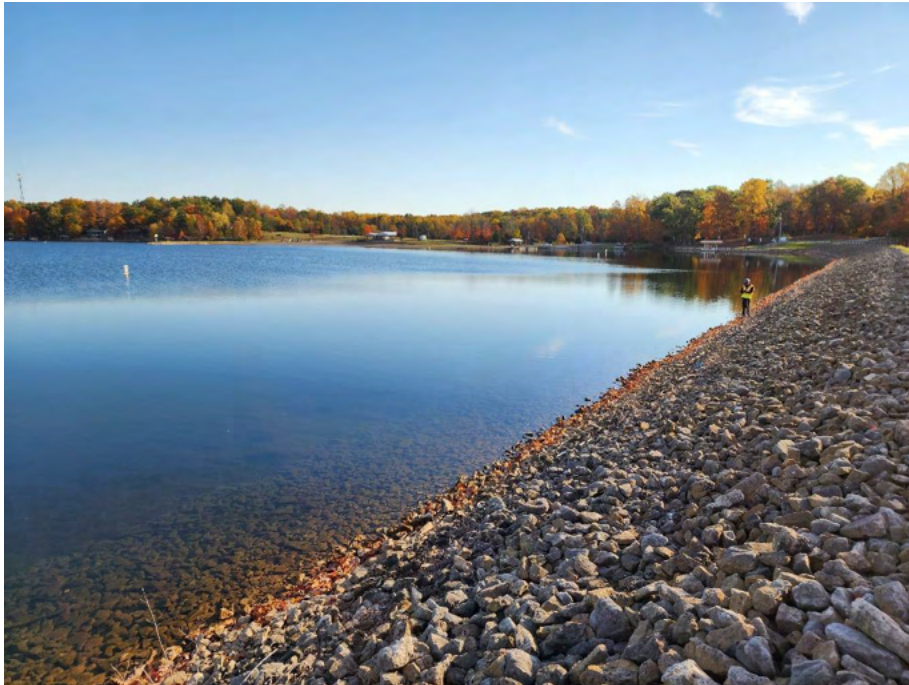
Top: Upstream slope from right side; note riprap slope protection with leafy debris along waterline

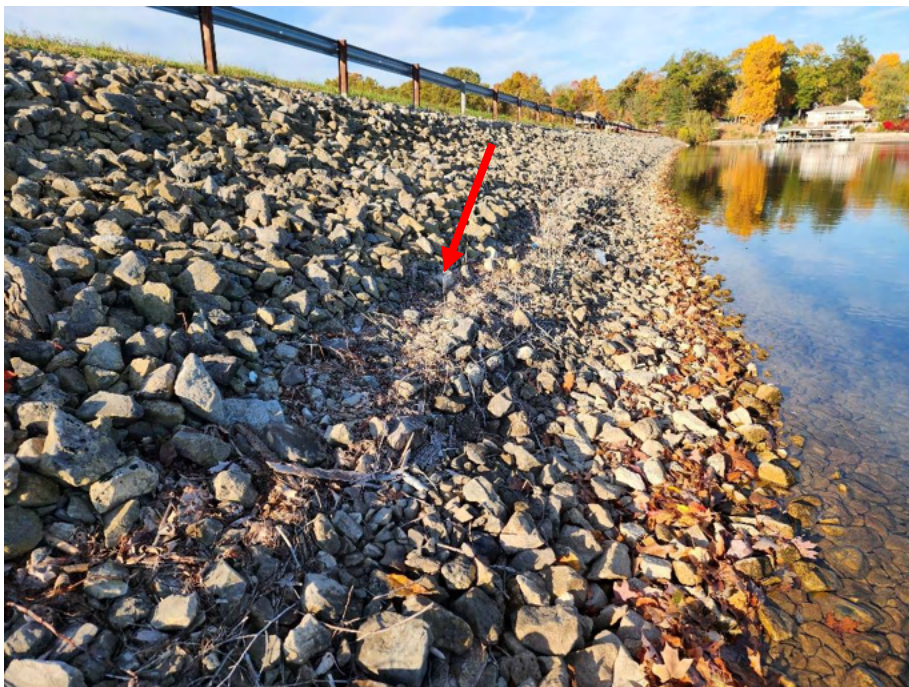
(A-10) Trees were observed within 25 feet of right abutment. Woody debris, leaves and a large log on shoreline.
	(A-11) Grass and weeds were growing in riprap slope protection

Bottom: Upstream slope from left side; note riprap slope protection with some grass and weeds near waterline

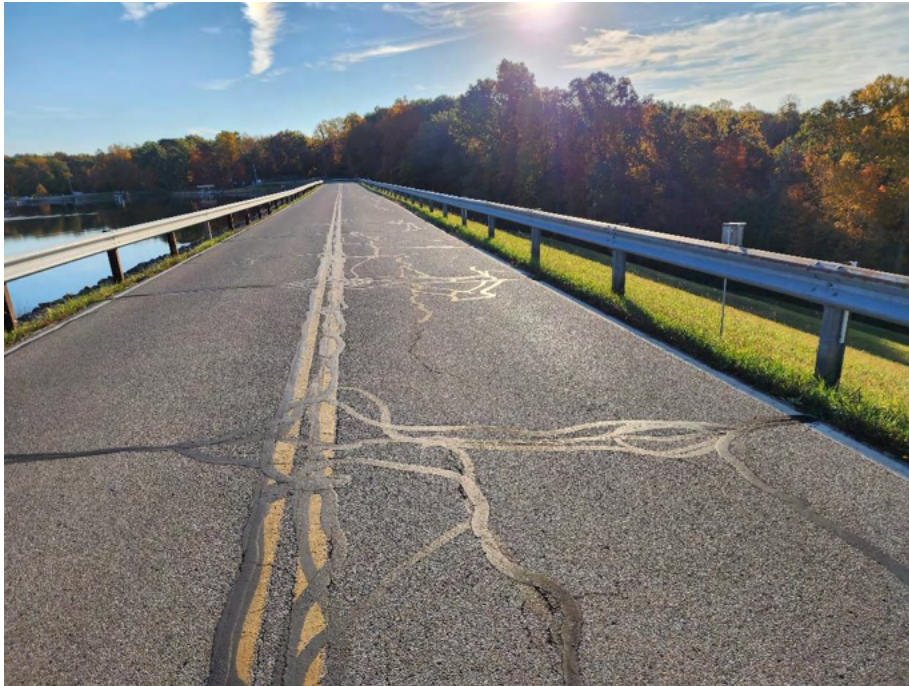
Top: Embankment crest from right side; note guardrail along edges

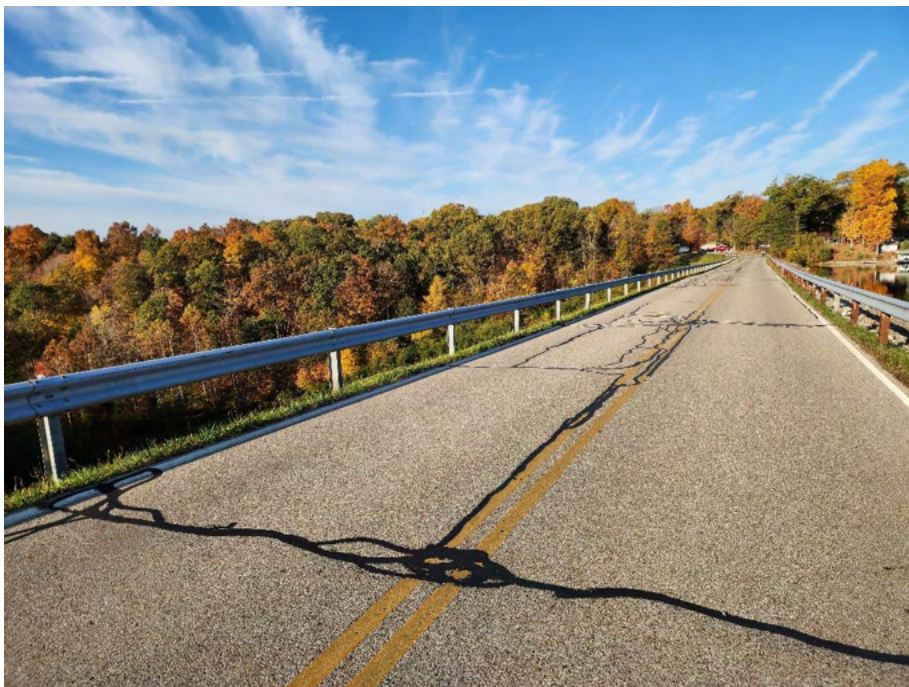
Sweetwater Drive is an asphalt road along the crest with guardrail on both the upstream and downstream sides. The asphalt pavement surface exhibited transverse and longitudinal cracks which appeared to have been sealed, are consistent with the age of the asphalt, and do not appear to be indicative of embankment instability. The road appeared to have been constructed with a low point near the center of the dam. The crest was considered “**Acceptable**” according to IDNR rating criteria.

Bottom: Embankment crest from left side; note previously sealed transverse cracks

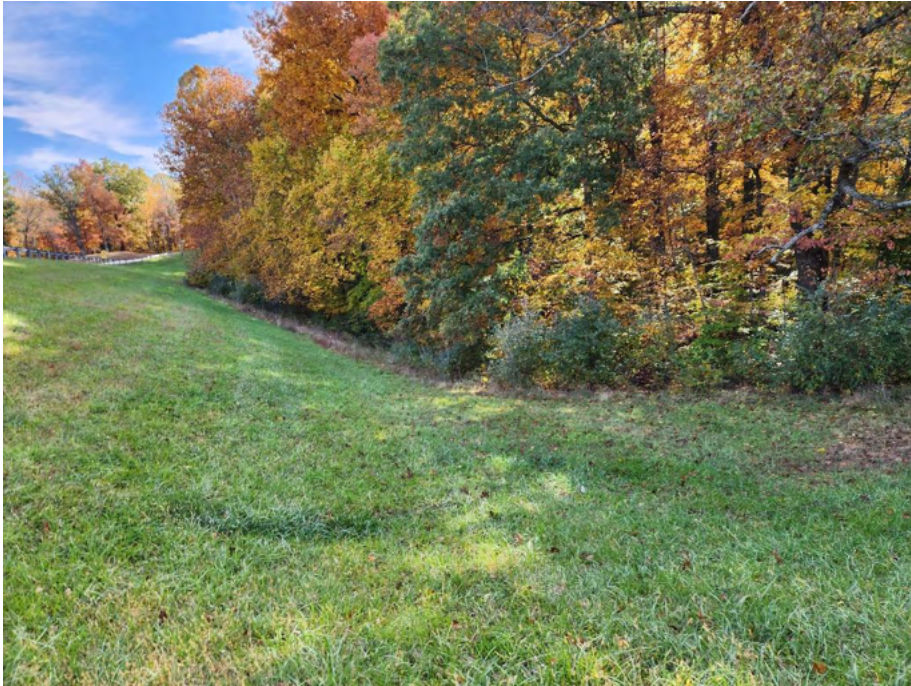
Top: Downstream slope at left abutment; note trees and brush within 25 feet

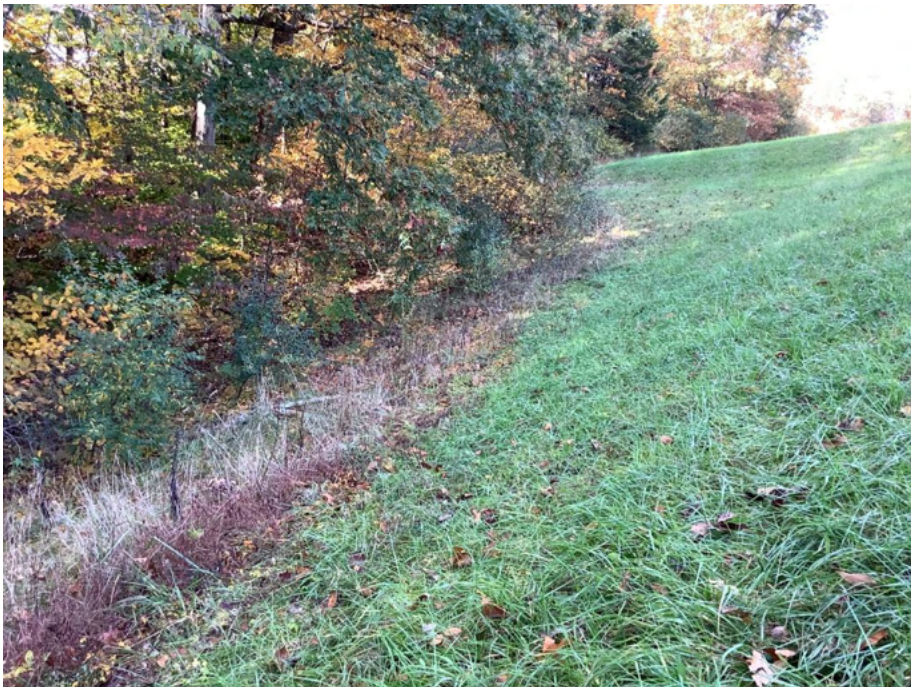
Bottom: Downstream slope near left side; note trees, brush and tall grass on toe within 25 feet

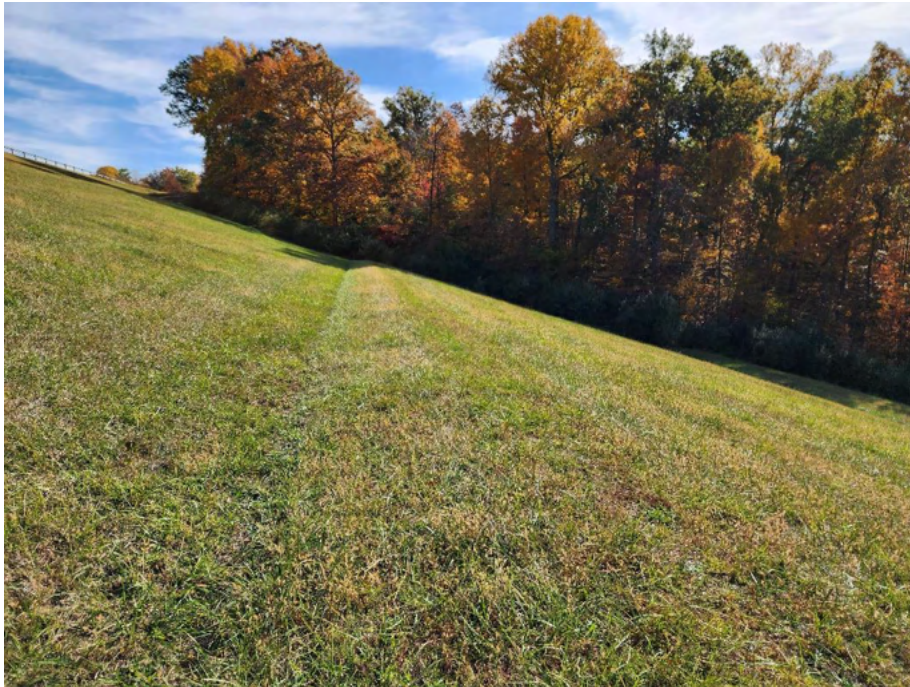
(C-10) Trees and brush were observed within 25 feet of right abutment, left abutment, and toe. Unable to thoroughly inspect left and right groin ditches or right abutment components.

Top: Downstream slope looking left; note trees and brush within 25 feet of dam

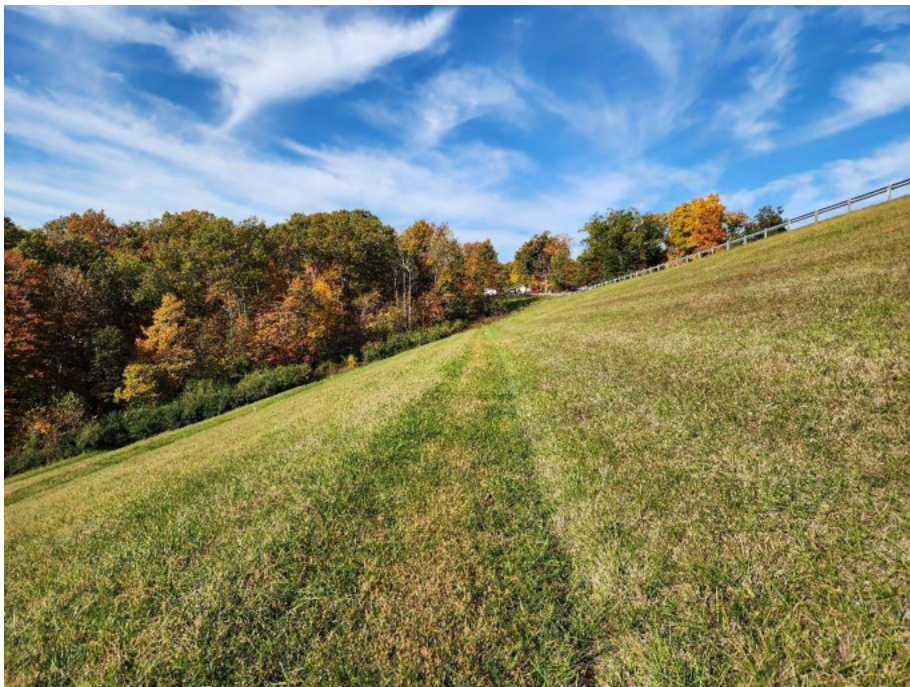
Bottom: Downstream slope near left side; note adequate grass cover and generally uniform slope between benches

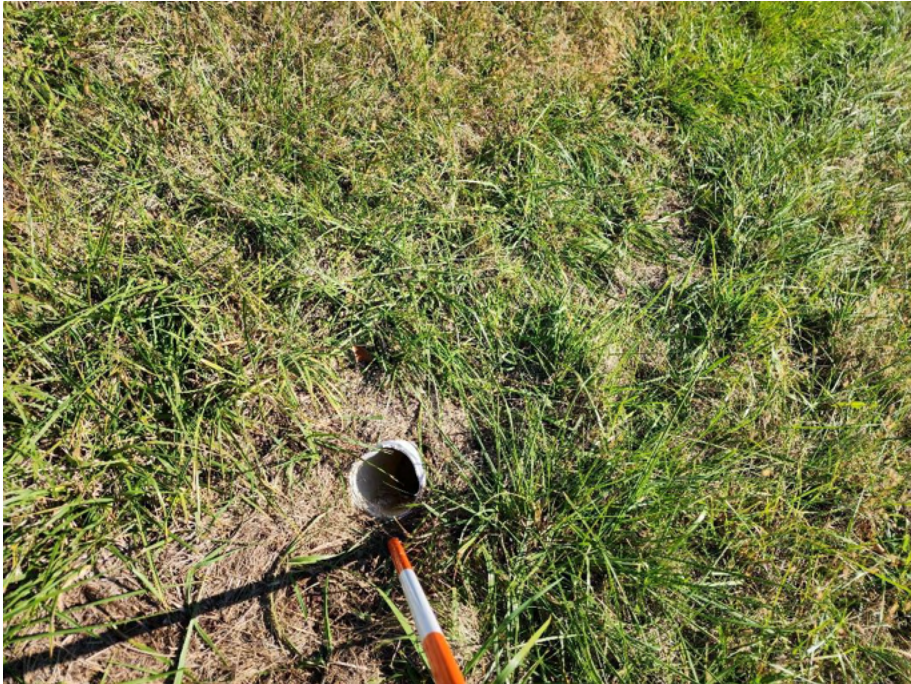
(C-12) Soft, bare and rutted areas were observed on the far left abutment; Bench drain cleanout pipes were damaged at the middle left, lower right, and lower left with caps on the ground.

Top: Downstream slope drain cleanout; lower left bench drain cleanout appeared broken. Middle left and lower right cleanouts were also broken.

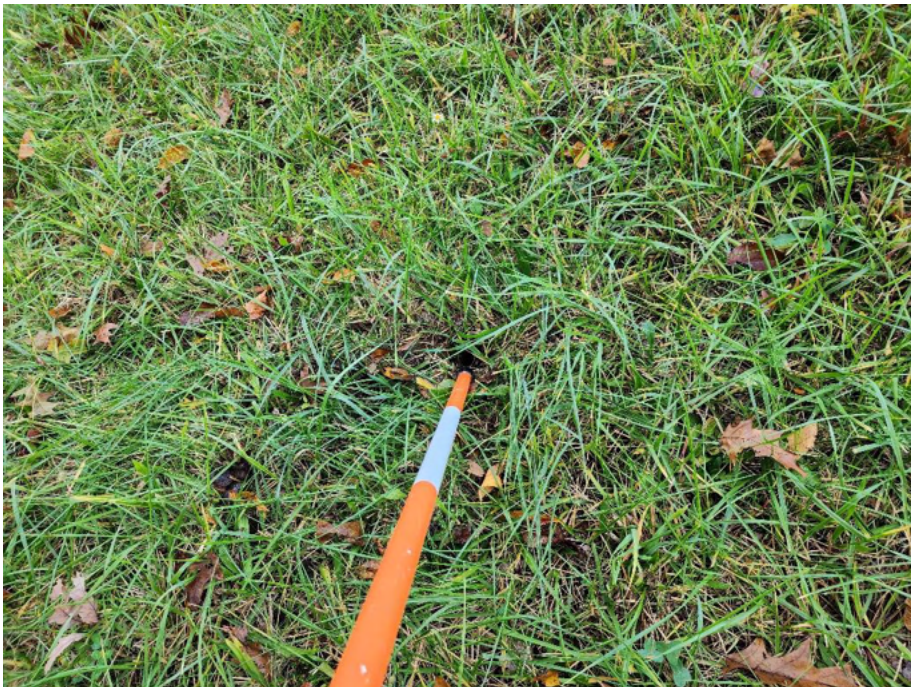
(C-11) A few small animal burrows were observed along the slope

Bottom: Downstream near middle; typical minor burrow along slope.

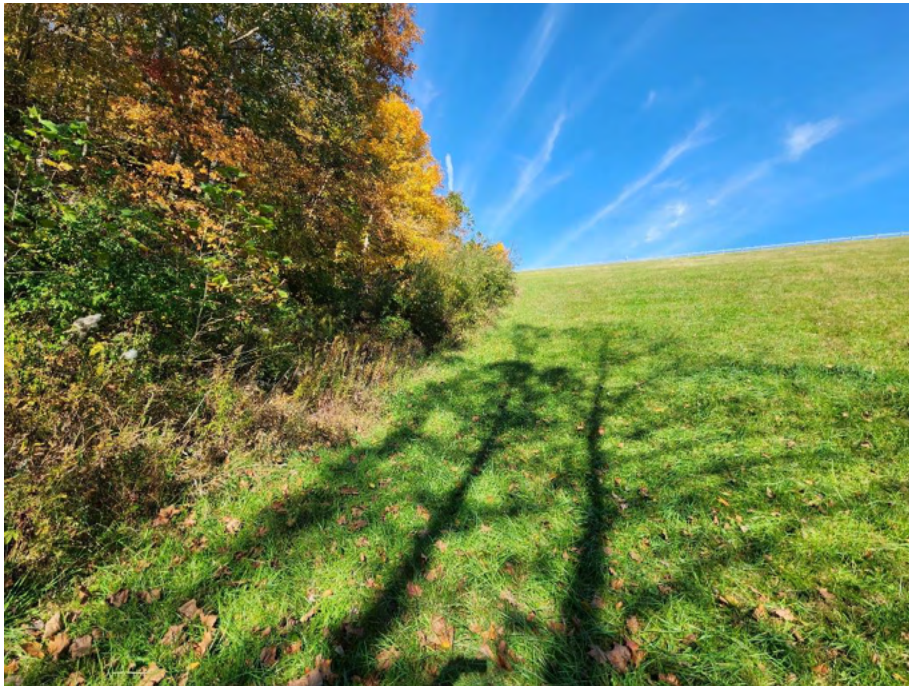
Top: Downstream slope at right abutment; note trees and brush within 25 feet of dam

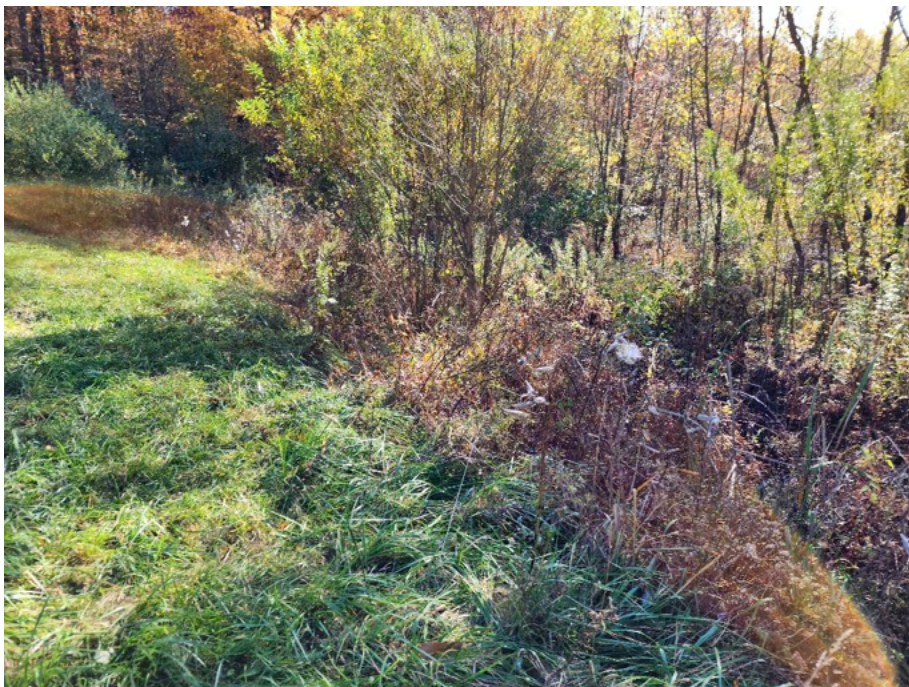
A large wet area was observed at the downstream toe, near the right side of the embankment. This area has been noted in past inspection reports. Dense vegetation was present which prevented a thorough inspection of the area. Clear seepage last observed in 2010 at the left abutment or evidence thereof was not observed at the time of this inspection. Seepage was considered “**Acceptable**” according to IDNR rating criteria.

(D-5) Large wet area observed at downstream toe with dense vegetation some aquatic. Drainage channel appears to run along the toe of the dam.

Bottom: Downstream slope at toe; note large wet area overgrown with vegetation

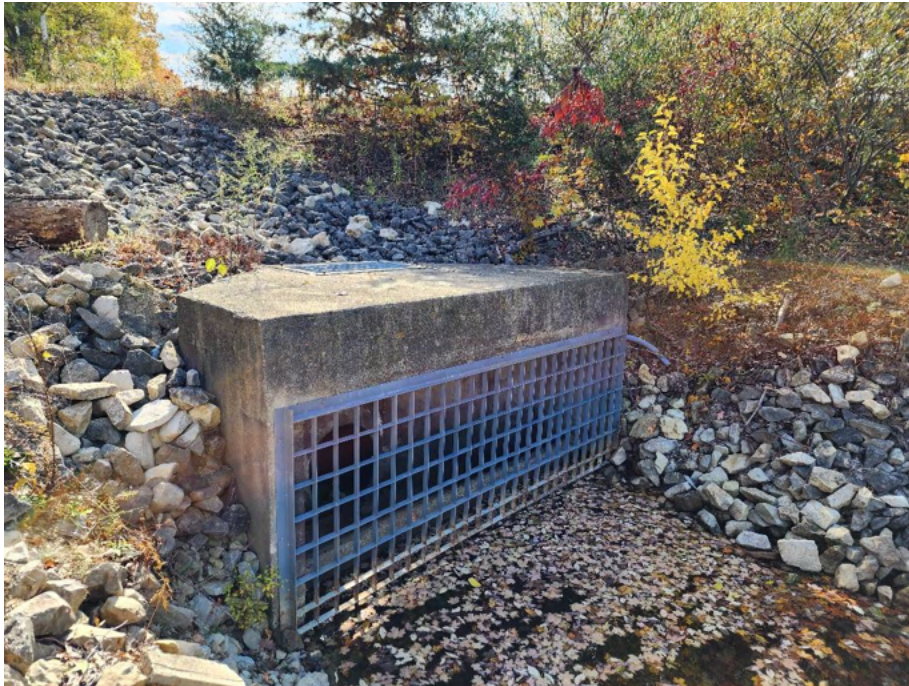
Top: Principal spillway inlet; note bottom portion of trash rack accumulated debris and some fallen riprap on the right sides

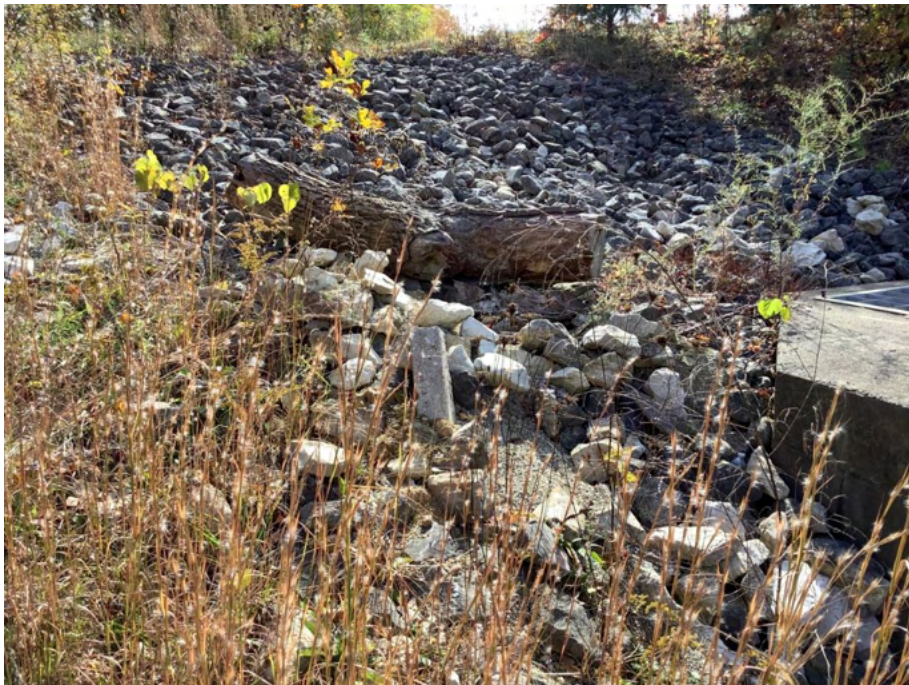
Bottom: Principal spillway inlet looking downstream of inlet; note woody debris and intruding vegetation within riprap

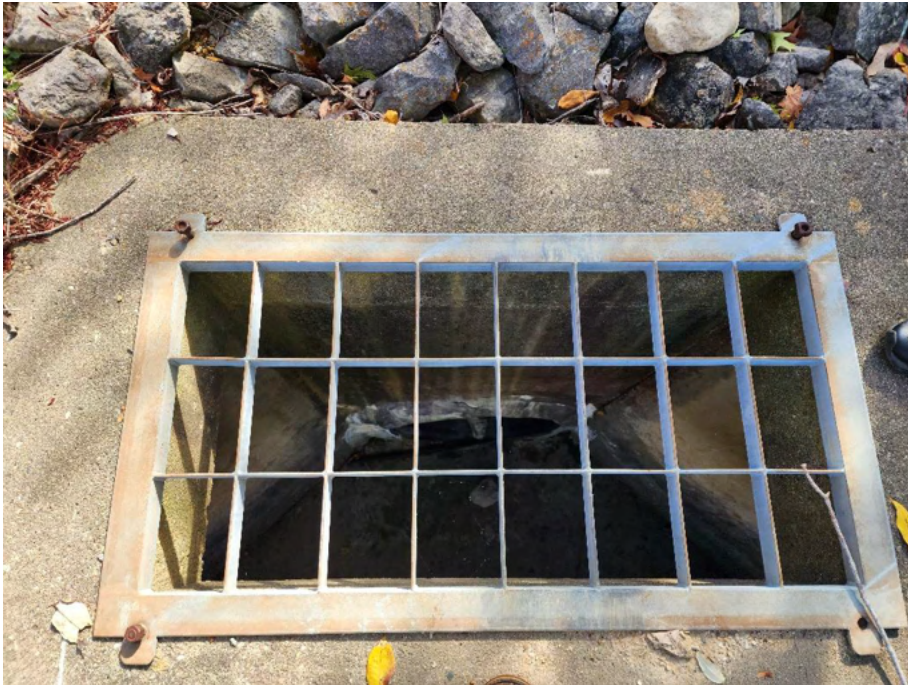
Top: Principal spillway inlet top; note trash rack on top of inlet has missing hardware

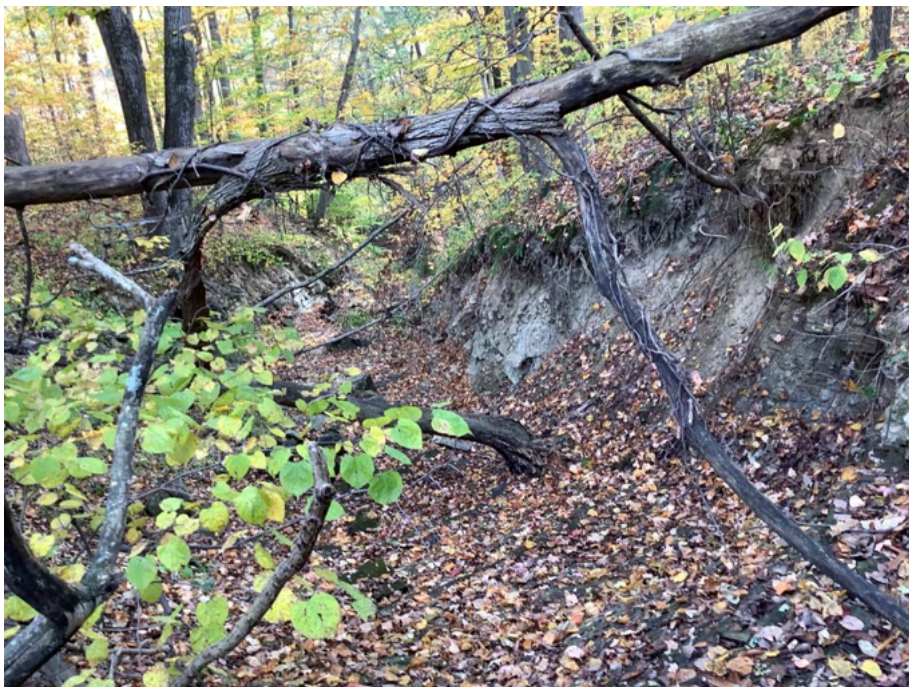
68	Vegetation	Principal Spillway	Outlet	Fallen tree downstream of outlet
69	Note	Principal Spillway	Outlet	Significant erosion downstream of outlet
70	Encroachment	Auxiliary Spillway	Inlet	Several obstructions such as volleyball net, telephone pole, and signage.
71	Surficial	Auxiliary Spillway	Inlet	Sporadic bare areas and sand covered volleyball area
72	Surficial	Auxiliary Spillway	Control Section	Pavement cracking some patched
73	Vegetation	Auxiliary Spillway	Outlet	Vegetation blocking outlet and side slopes
74	Drainage	Auxiliary Spillway	Outlet	Drainage ditch culvert
75	Encroachment	Auxiliary Spillway	Outlet	Several minor obstructions including construction materials

Bottom: Principal spillway outfall looking downstream, not fallen tree and erosion downstream

In September 2019, Burke completed preliminary calculations for armoring the outlet channel downstream of the principal spillway after significant erosion was observed along the right abutment. Conceptual layouts were developed for several hard armor solutions. CSCD plans to address and implement final design for this work in the future.

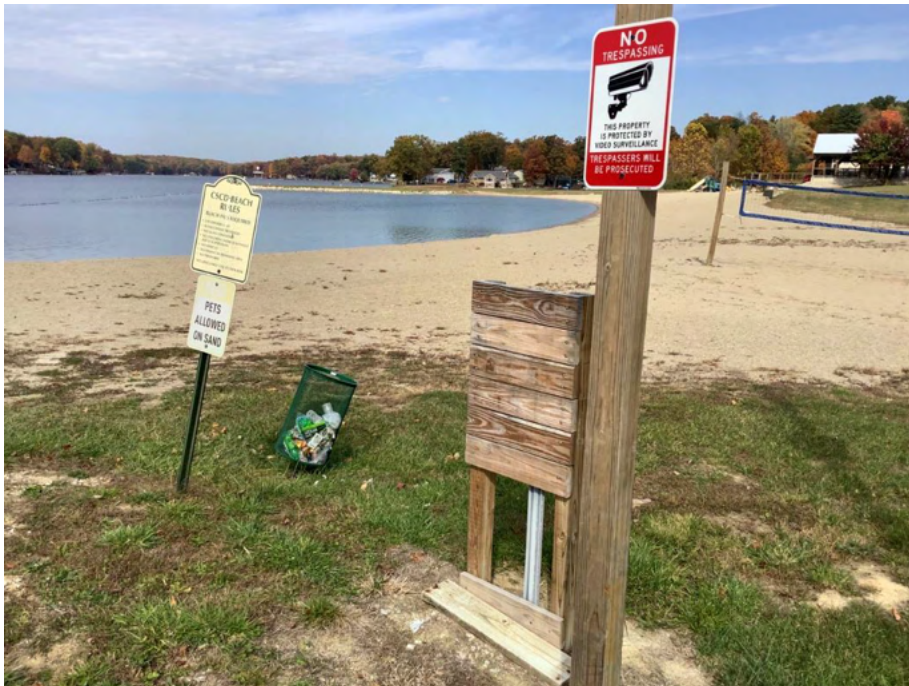
The auxiliary spillway open channel is in natural ground to the left of the embankment. Except for the light pole and volleyball net, the inlet is free from obstructions. Sporadic bare areas and sand covered volleyball courts could exhibit erosion during activation of the spillway. The spillway side slopes are covered with trees and brush as is the downstream portion of the channel prior to the outlet. Minor surficial pavement cracking along the roadway control was observed. Several minor obstructions are within the outlet gravel parking lot area including construction materials. As noted in Section 1.7, the methodologies used previously to evaluate the overall spillway capacity are different than that currently required by IDNR. The auxiliary spillway was considered “**Acceptable**” according to IDNR rating criteria.

Top: Auxiliary spillway inlet; note volleyball court, utility pole, and signage within upstream open channel portion with a few bare areas

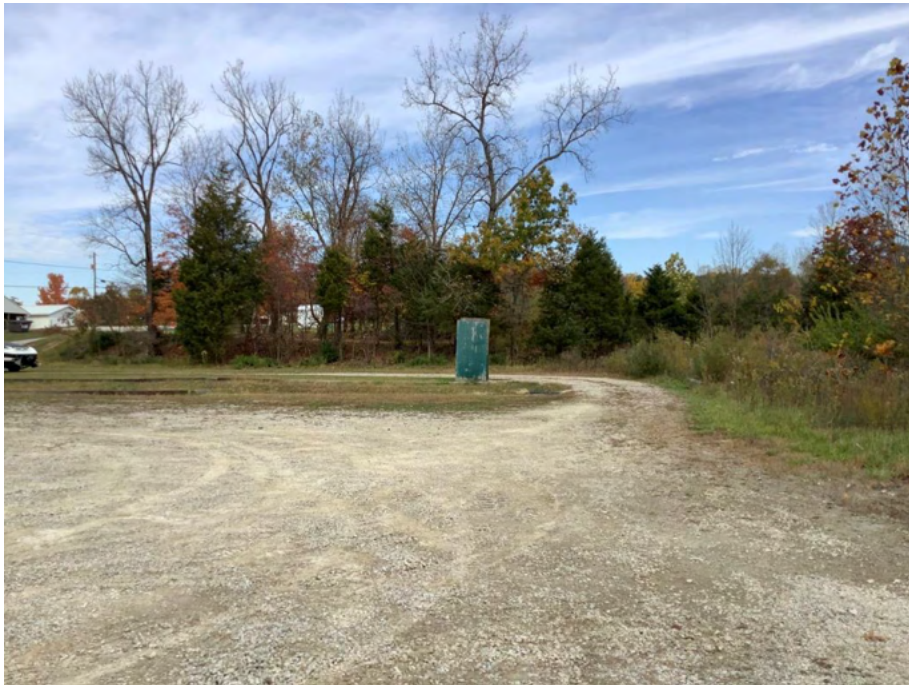
Top: Auxiliary spillway left side; note trees and brush along side slopes of downstream open channel portion

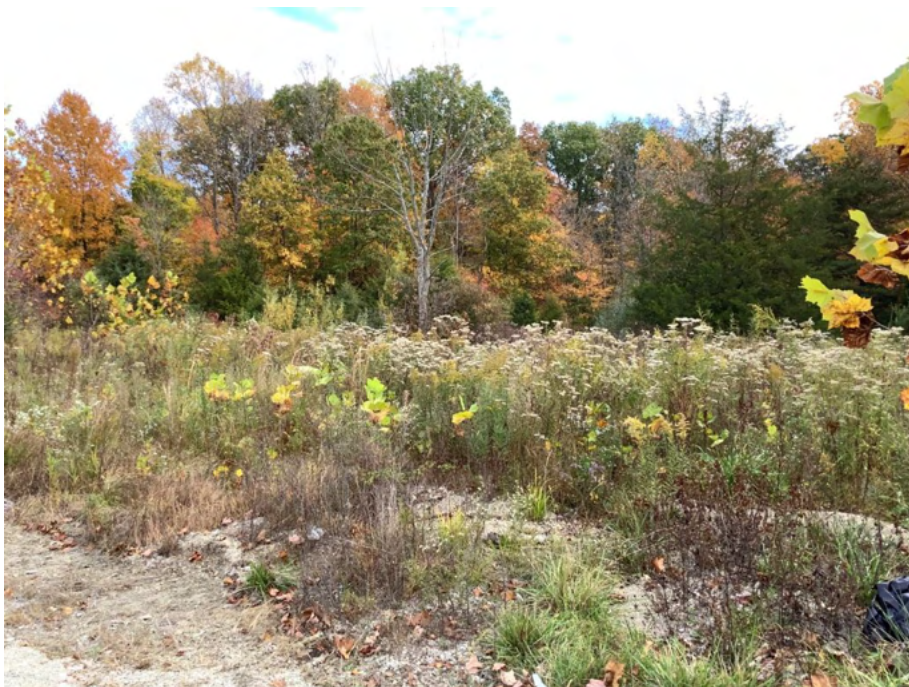
Bottom: Auxiliary spillway outlet; note trees and brush along downstream spillway channel.

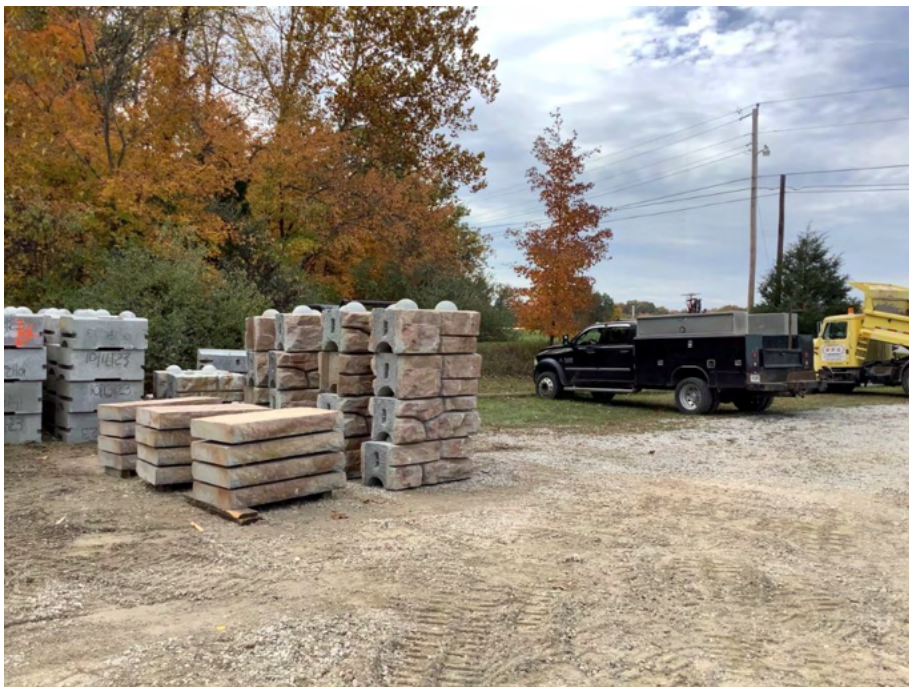
Bottom: Auxiliary spillway outlet looking right, note temporary construction materials in channel
